MTL TR 91-31

METALLURGICAL AND MECHANICAL ANALYSES OF A FAILED FUSE HOLDER FROM THE XM264 ROCKET

WEGO WANG, JOHN C. BECK, and MARTIN G. H. WELLS
METALS RESEARCH BRANCH

August 1991

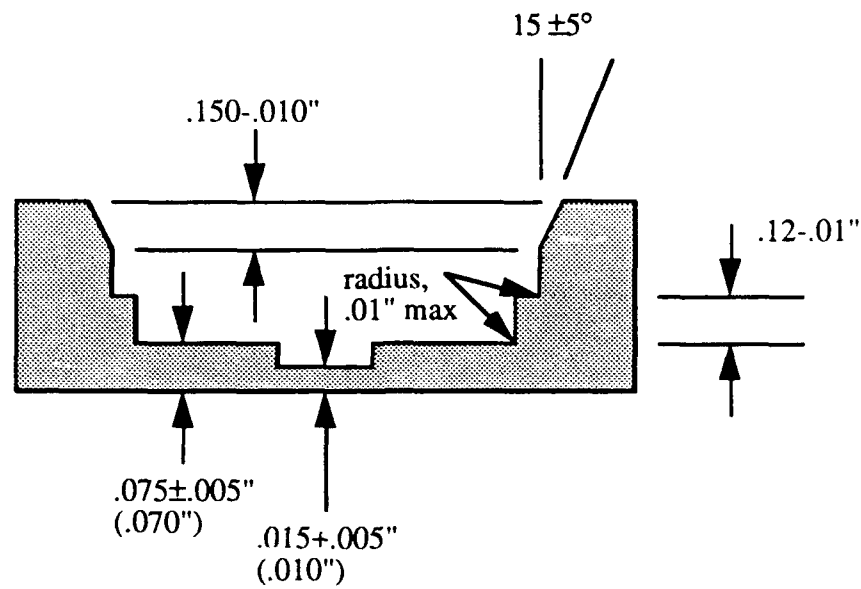
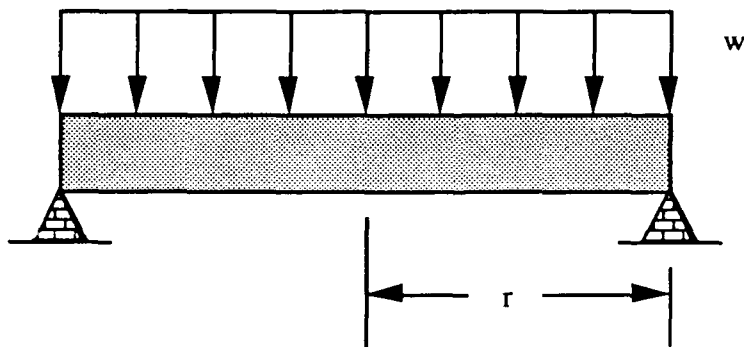
Figure 13. Configurations for stress analysis

Based on our metallurgical analysis that the material was basically sound and the locations of the cracks observed, we concluded that these cracks were caused by mechanical stresses exceeding design values rather than by substandard material strength. The complex part geometry has limited the degree of accuracy for any quantitative stress analysis. Two mathematical formulas (4) were employed for analysis based on certain approximations and assumptions with regard to material properties, geometric complexity and boundary conditions. It is also often very difficult to decide whether a plate should be considered as freely supported or fixed, whether a load should be assumed uniformly or otherwise distributed. The simulated configuration for the current study is presented in Figure 13. The center-disc was approximated as a flat plate of average thickness with a firmly fixed edge. The load is assumed to be uniformly distributed. The maximum bending stress and deflection can then be calculated by the following equations:

(a) True configuration with the measured dimensions in parentheses

(b) Simulated configuration

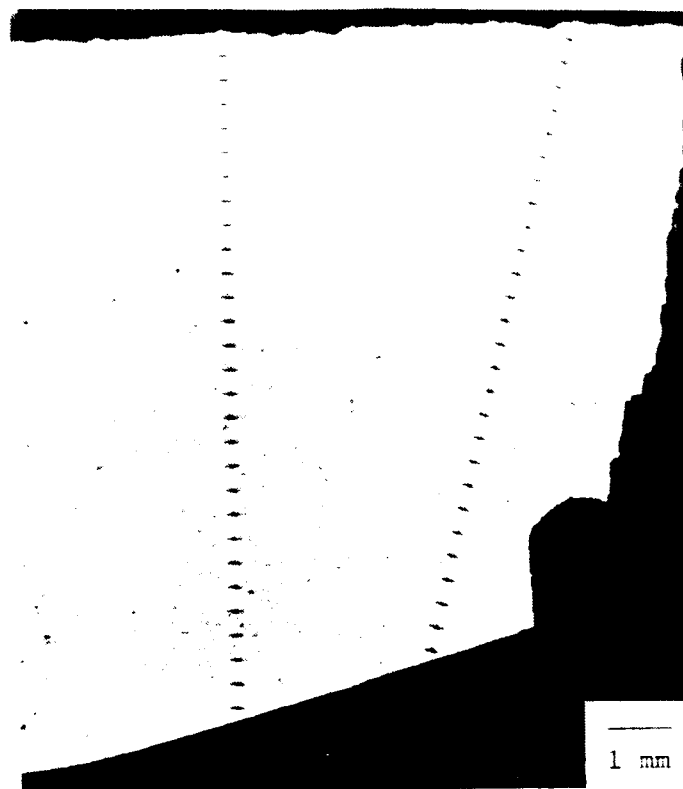
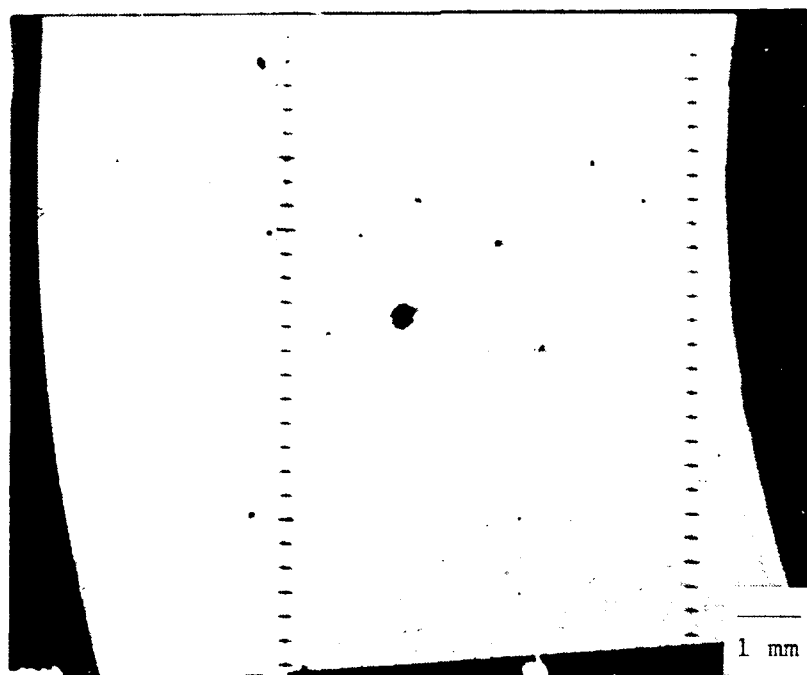
Figure 1A. Photographs showing the microhardness testing locations with a descending testing sequence from the left-top.

(a) The specimen cut from the thin center-disc area

(b) The specimen cut from the circumferential bulk area
